EVALUATION OF FLAWED COMPOSITE STRUCTURAL COMPONENTS UNDER STATIC AND CYCLIC LOADING

T. R. PORTER

Boeing Aerospace Company
A Division of The Boeing Company
Seattle, Washington

NASA Lewis Research Center
Contract NAS3-19709
Gordon T. Smith, Project Engineer

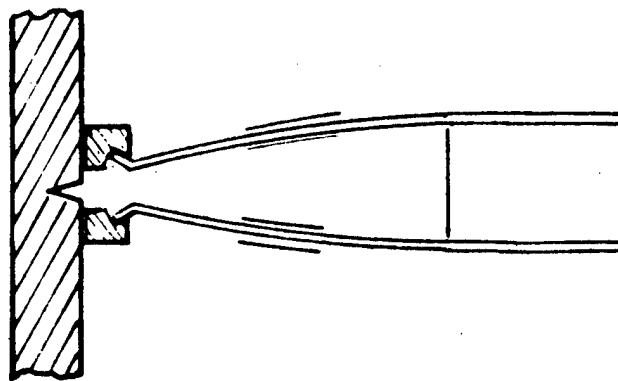
Figure 8. Clip Gage Installation on Test Specimens Containing Defects

SECTION A-A FOR SLITS

All flawed specimens were continuously instrumented throughout each test to detect both the time, at which and the manner in which, structural changes occur in the region immediately surrounding the defect. This was accomplished by continuous monitoring of the displacement across the stress concentrations using clip gages. Clip gages were spring-loaded against knife edges bonded to the specimen surface at the specimen centerline. For all but the 5/8 FP holes, the knife edges were located immediately above and below the stress concentration, as illustrated in Figure 8. For the test specimens containing the largest full penetration holes, knife edged supports were placed against the hole surfaces. In static tests, both clip gage and load cell were connected to an X-Y recorder to produce a recording of load versus clip gage

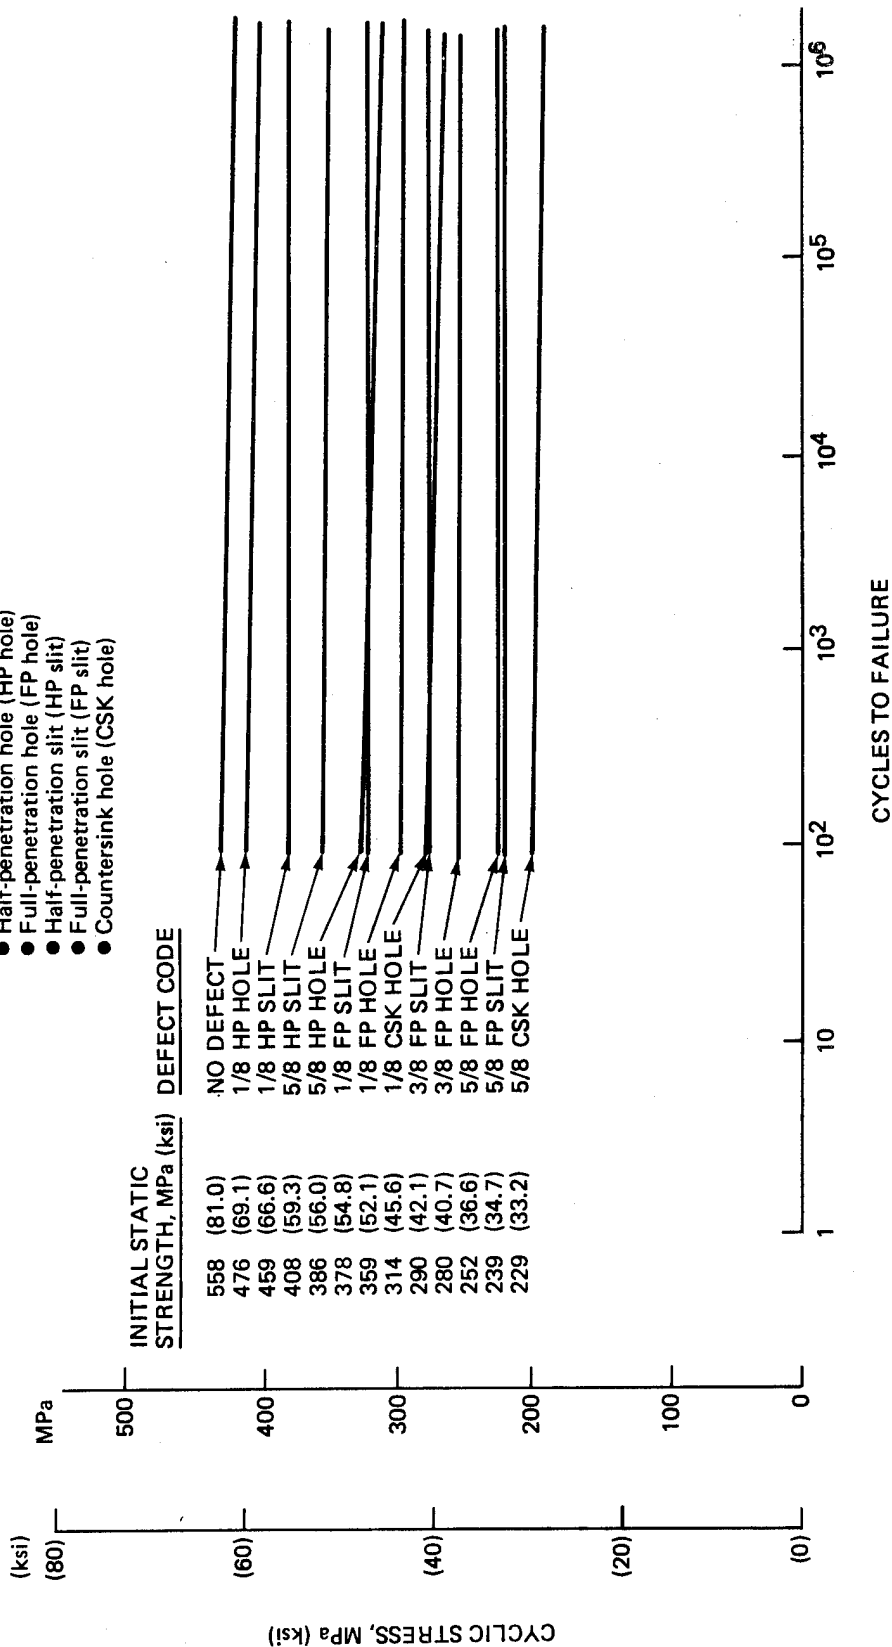
Figure 73. Minimum Fatigue Behavior for L1 Laminate Test Specimens Having Various Defects

- No defect
- Half-penetration hole (HP hole)
- Full-penetration hole (FP hole)
- Half-penetration slit (HP slit)
- Full-penetration slit (FP slit)
- Countersink hole (CSK hole)

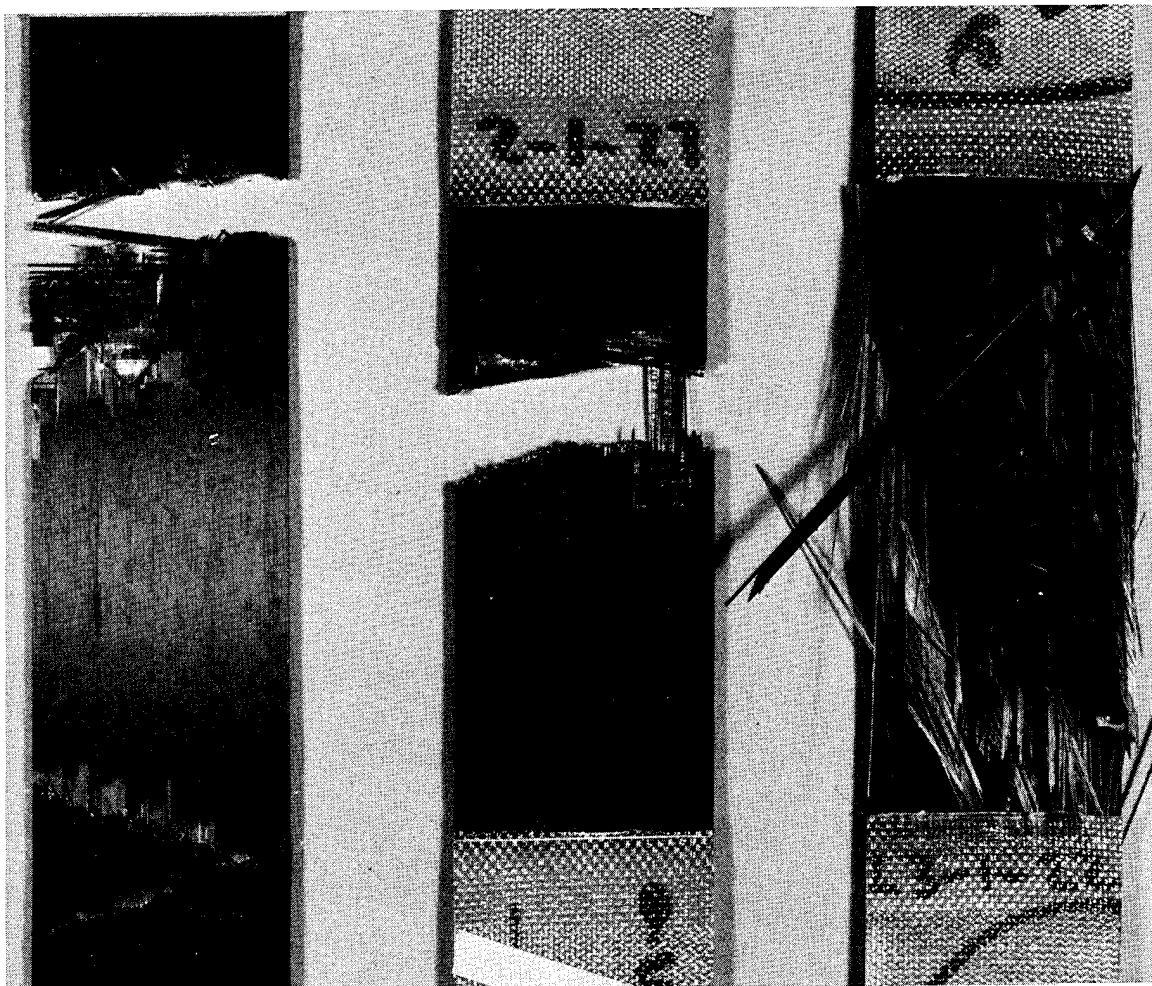
Figure E-1. Test Specimens With No Initial Defect

- Specimen L1-10-2
- Laminate L-1
- 10^3 cycles
- Residual static

- Specimen L2-1-2
- Laminate L2
- Preload
- Residual static

- Specimen L3-1-22
- Laminate L3
- 10^3 cycles
- Residual static

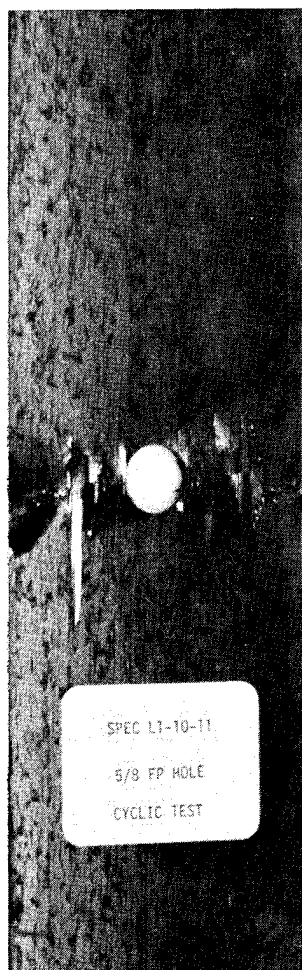
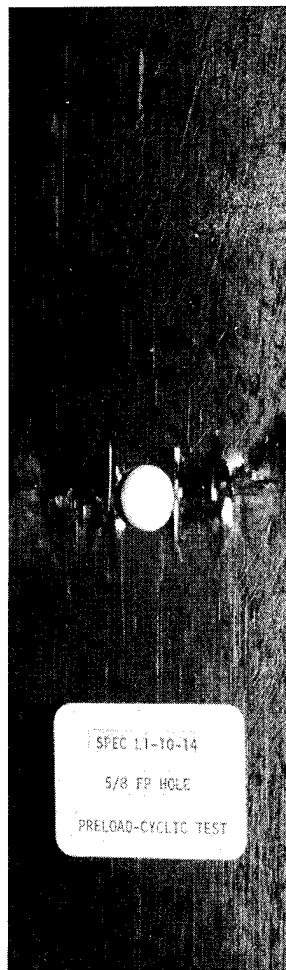
Figure E-15. Tension-Compression Fatigue ($R = -1.0$) Laminate L1 Test Specimens Containing a Full- and a Half-Penetration Hole

- 7,300 cycles
- Fatigue Failure

- 22,800 cycles
- Fatigue failure

- 3,100 cycles
- Fatigue failure
